**The 'Big Dig at Paisley Abbey Drain 2019'.
Archaeological Excavation
Data Structure Report
Project 4965**

On behalf of: Renfrewshire Council

Project Number: 4965

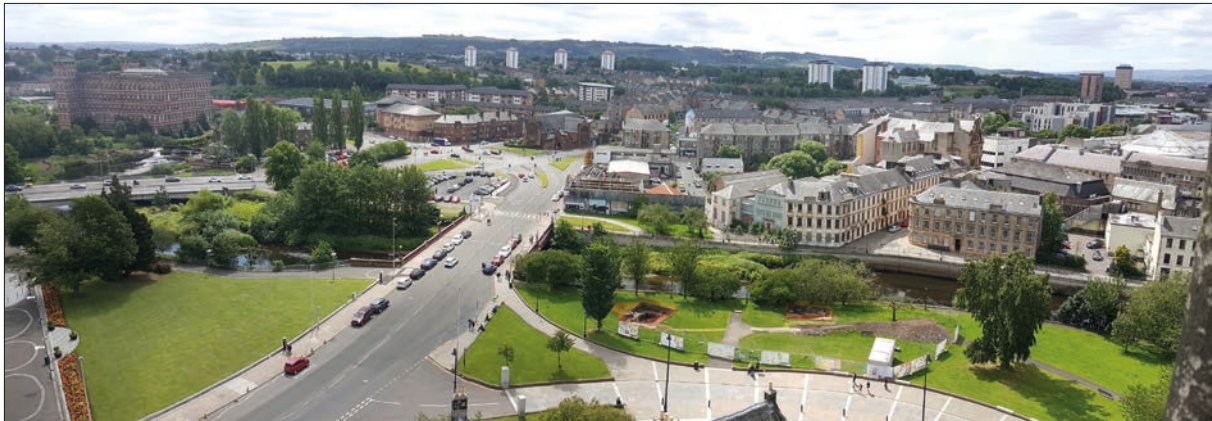
Plate 1: General view of site

- 3.1 Two trenches were located in a small grassed municipal park and garden to the south of Paisley Abbey next to the River Cart (NGR: NS4849 6388). The present banks of the River Cart are retained by a stone wall with iron railings, a footpath next to the wall, and then a row of trees and grass beyond. It is thought that the present retaining wall replaced an earlier wall and that the original river bank was further east, in ground that has now been built up behind the latest retaining wall. In addition, a major modern sewage pipe was inserted next to the retaining wall.

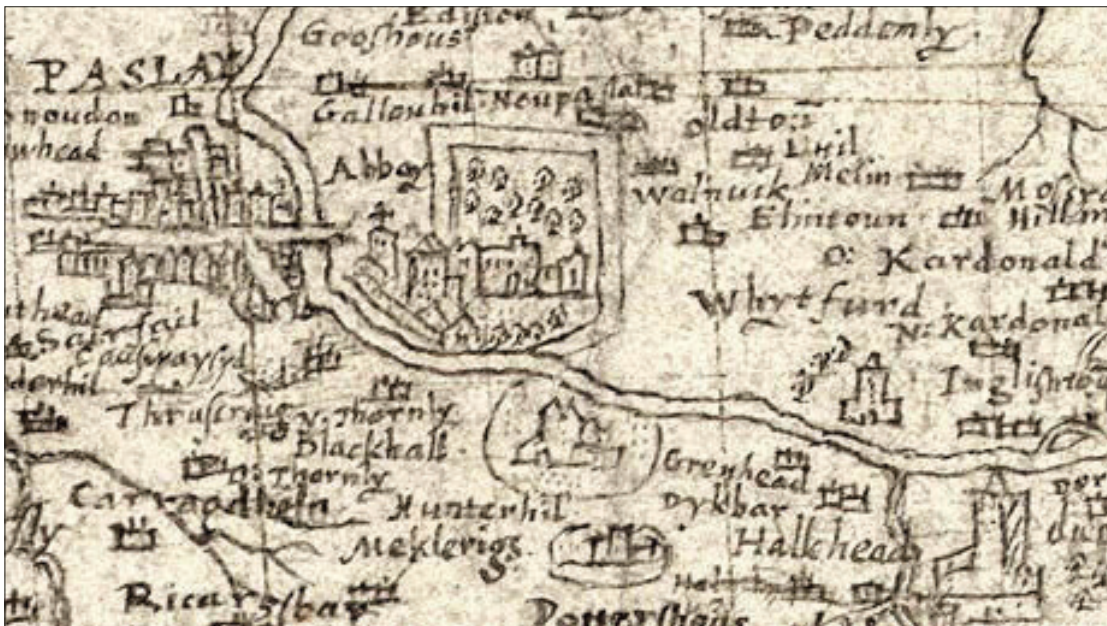
Figure 2: Pont's map produced between 1583-1614 not long after the Abbey tower collapsed

- 5.1 The Cluniac Abbey of Paisley was founded as a priory at its present location the late 1160s and became an abbey in 1219. The Abbey and its estates were one of the richest Cluniac foundations in the country but the Abbey suffered during the Wars of Independence and burned down in 1307. It underwent an ambitious building programme in the 1450s under the direction of the Abbot Thomas Tervas. The tower collapsed into the choir in the 1550s before further disturbances and damage occurred during the Reformation in 1561 after this the Abbey transferred into private hands. Much of the Abbey as it survives today is the result of various renovations and re-buildings from the 19th century, using the surviving walls and foundations, although the nave is largely original.

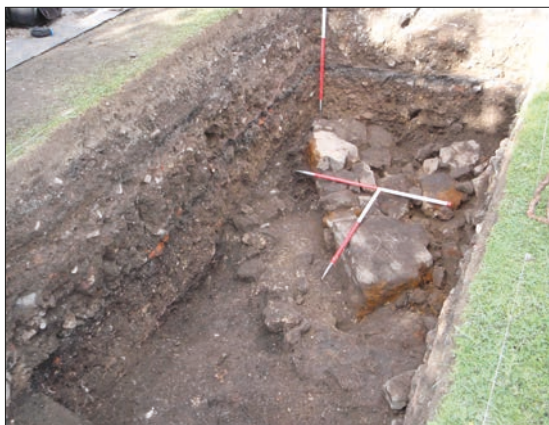
Plate 2: Possible medieval wall from the south

19th or early 20th century tenements. Excavation continued below the footpath to reveal the remains of a medieval stone-built wall (Plate 2). Excavation stopped at this point. As the wall appears to have been built over the top of the Drain, it was not possible to investigate the Drain, manhole or side drain.

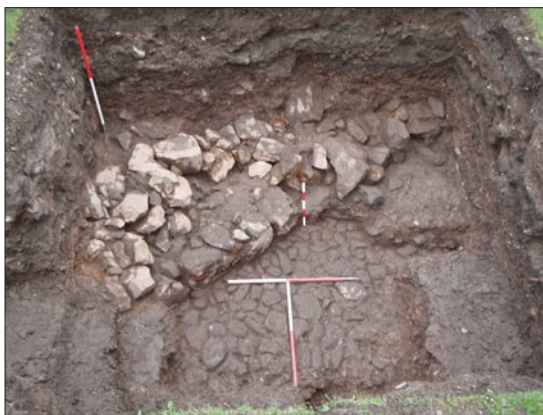
Plate 3: Medieval wall and cobbled surface from the west

6.3.1 In 2011, two trenches were excavated (Will and Ceci); one to expand the trench from 2010 to investigate the wall foundation, the other (further to the north), to investigate why the Drain changes direction, and does not follow a straight line. The trench (4 m by 4 m) to investigate the wall (discovered in 2010), was situated slightly to the south of the previous trench overlapped with it. As the work in 2010 had demonstrated that the upper 0.8 m consisted of modern disturbed material, a machine was used to remove the upper deposits before excavation continued by hand. Excavation revealed a substantial stone wall that ran at an angle, covering the eastern side of the trench. To the west of the wall, a cobbled surface was uncovered that seemed to respect the wall (Plate 3). Two sherds of imported German stoneware pottery were recovered from the layer above the cobbles which would date to the late medieval period.

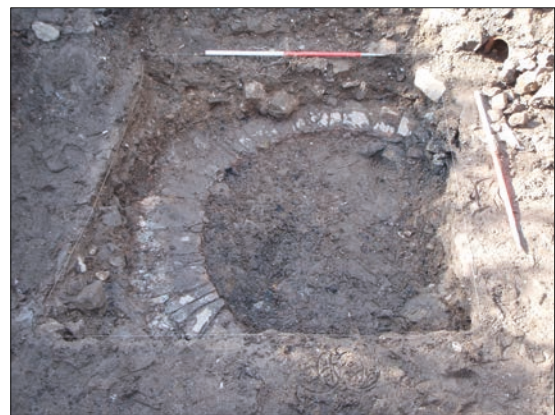
Plate 4: Possible medieval oven or well from the east

6.3.2 The other trench was located 10 m to the north of the first trench and was 4 m by 4 m in size. A test pit excavated in 1991 (O'Brien) in this area had established that there was a deep deposit of modern landscaping material similar to that encountered in the recent trenching programme. As a result, the upper deposits were removed by machine and then excavation was by hand. Once the modern overburden was removed, a stone built circular structure was uncovered that may be an oven or possibly a well (Plate 4). The structure was 1.7 m in diameter and appeared to be made from slates. Excavation stopped at this point and the feature was not investigated. The oven or well could relate to buildings associated with the Abbey and would explain why the Drain changed direction if, for example, there was an existing building at that location when the Drain was built.

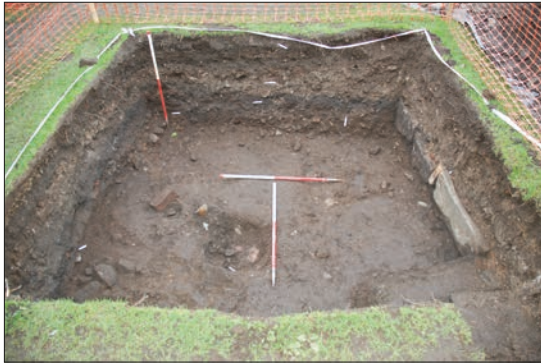
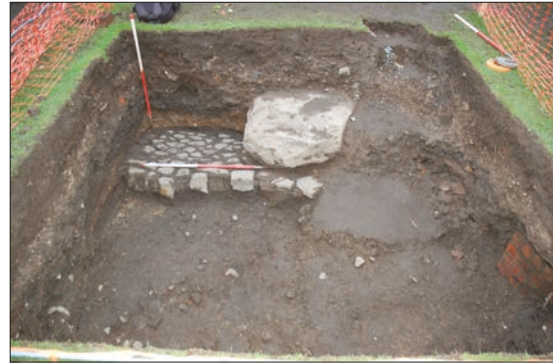
Plate 5: Trench with nineteenth and early twentieth century remains from the south

Plate 6: Trench with nineteenth century cobbled surface and masonry from the north. The access manhole to the Drain is in the bottom right of the picture

block, which appears to be redeposited, could be from one of these buildings (Plates 5-6). The cobbles stopped in a straight line with the masonry at the edge, and this line may mark the cut for the access trench to build the concrete roof. Excavation stopped at this point.

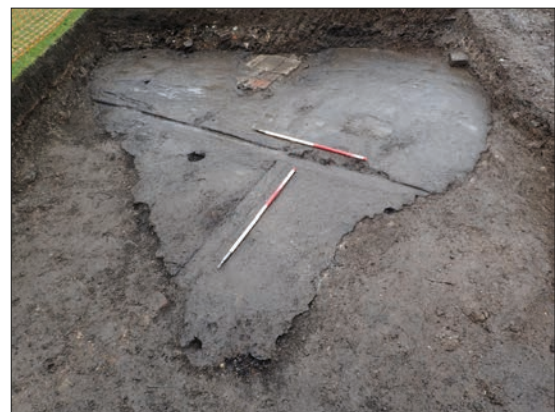
Plate 10: Bitumen surface and brick foundation from the south-east

10.3.3 The full extent of the layer of bitumen including the extension to the trench measured 7.70 m long by 4.57 m wide, and was 0.05 m thick. The bitumen layer (1003/1029) bore the imprint of wooden planks or beams; one imprint measured 3.4 m long and 0.17 m wide and ran east and west, four smaller imprints were up to 1.5 m long and 0.1 m wide and ran north-south. Two of them were found to the south of the larger strip and two others less visible to the north of it. These imprints could be from timber foundations for a possible light wooden building with the bitumen layer acting as a damp course.

10.3.4 In the north west edge of the trench against the west baulk, the bitumen layer run up to a brick structure or foundation (1002) which measured 1.15m by 0.6 m in size. It was mainly constructed from white bricks bearing the name of 'HURLFORD', orange bricks and cobblestones round the edges and appeared to be set in a bedding layer of white sand and gravel (1004). A brickworks operated in Hurlford in East Ayrshire from 1857 until the 1980s. As the brick structure was located within the area that was to form a step in the trench, the structure was not investigated but protected. The structure (1002) seems to have been built at the same time as the bitumen layer (1003).

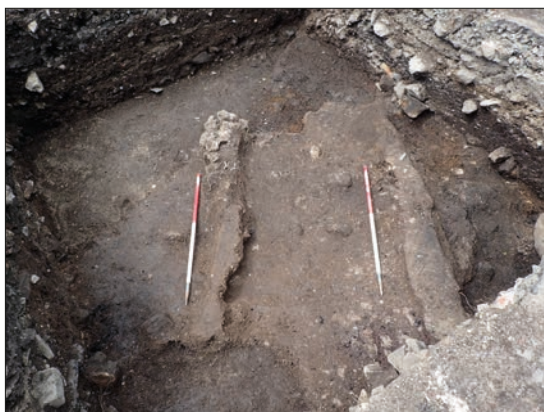
Plate 12: The three parallel trenches 1021, 1017 and 1020 from the west

full width was revealed. 1017 measured 2.7 m long by 1.10 m wide, and was truncated to the west by trench 1007. The full width of feature 1021 to the north, or feature 1020 to the south could not be uncovered due to the limits of the trench edges. Feature 1021 measured 2.7 m long and was 0.6m wide; feature 1020 was 1.1 m long and 0.6 m wide. Both were also truncated to the west by the trench 1007 and feature 1020 was also truncated by pit 1014 to the north. When excavated the three linear features all had steeply sloping sides with a flat base, 1021 was between 0.5 and -0.6 m deep, 1017 was 0.45 m deep and 1020 was only 0.15 m deep. All three linear features had similar fills, a firm dark brown silty sand (1022, 1012 and 1018) with frequent inclusions of small and medium sized sub-angular stones, long with fragments of coal. Artefacts recovered from the fills included a large fragment from a glass wine bottle that was decorated with the seal of the Earls of Dundonald who owned the lands round the Abbey in the 18th century. Other artefacts included clay tobacco pipe stems, medieval pottery and a sherd of imported stoneware pottery, possibly from Germany or the Low Countries as well as animal bones and oyster shells.

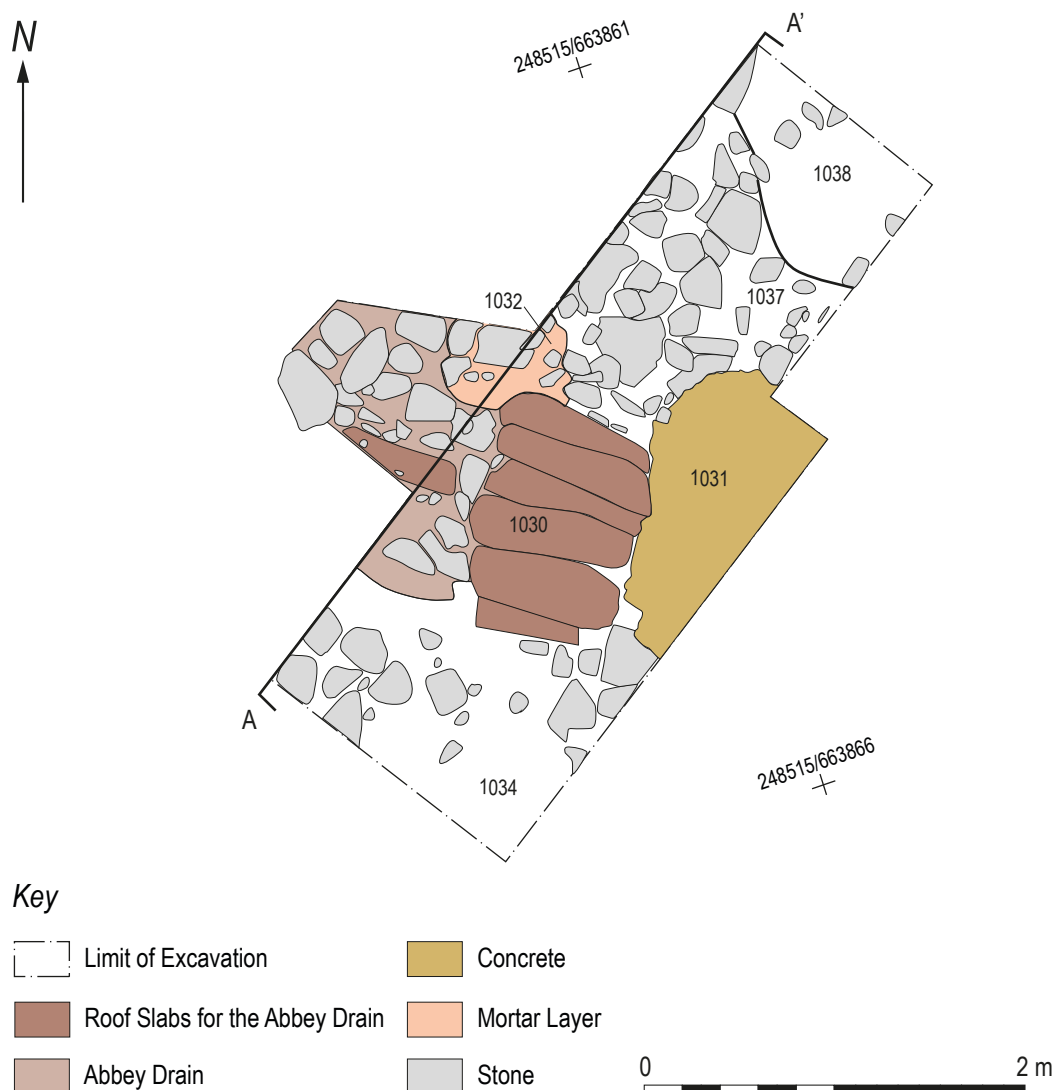
Figure 6: Plan of stone roof slabs 1030 of the Abbey Drain and concrete roof 1031 in MST

- 10.3.13** At this point, another step was established for safety reasons and excavation was limited to an area in the centre of the trench that measured 4.2 m north-east/south-west by 1.5 m north-west/south-east. As excavation continued, the bottom of the rectangular trench 1007 that separated the two halves of the trench was found and was a maximum of 1.8 m deep. This feature appears to be the trench that was dug to expose and repair the top of the medieval drain in the late nineteenth or early twentieth century. Excavation of the lower fill (1011) revealed concrete (1031) that has been used to repair the roof of the medieval drain (1030).

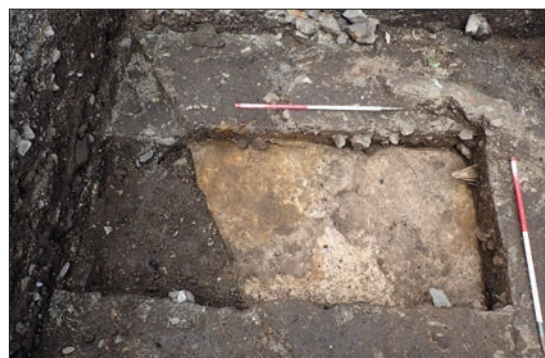
Plate 14: Sand and mortar layer 1027 from the south-east

10.3.15 To the north-east of the Abbey Drain (1030) the remnants of layers 1022 and 1040 were removed to reveal an extensive deposit (1025) of mid brown silty sand with frequent inclusions of pebbles and charcoal that was up to 0.4 m thick. Within this layer were two thin layers of sand and mortar (1026 and 1027). The first lens, 1026 consisted of loose light brown/orange sand with mortar inclusions and was between 0.02 and 0.08 m thick. The second lens, 1027, was similar

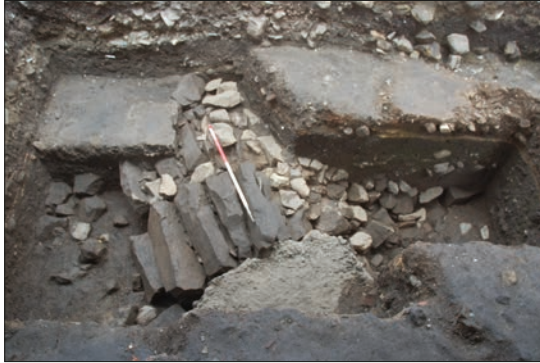
- 10.3.18** The top of the Abbey Drain roof (1030) was exposed in the middle of the deepest part of the trench. The roof of the drain was built with large stone roof slabs which were covered with small sub-angular stones, haphazardly laid on top of the roof and sealed by 1028/1034. A section of the roof slabs were exposed and the exterior of the roof was 1.9 to 2.0 m wide, and was composed of a drystone arch formed by eight large rectangular stones. The smallest measured 0.57 m long by 0.4 m wide and 0.2 m thick and the largest 0.87 m long by 0.32 m wide and 0.23 m thick.

Plate 15: General view of the stone roof slabs 1030 of the Abbey Drain from the east

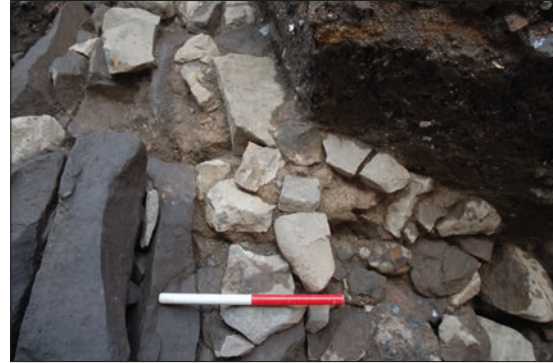
- 10.3.19** A small layer of mortared stone 0.6 m by 0.6 m (1032) was uncovered on the north-east side on the top of the Drain and seemed to continue in the north-west section of the trench. This was unusual because the roof is of drystone construction and mortar does not appear to be the remnants of a wall or another feature built next to the Abbey Drain. As the roof of the Abbey Drain was exposed (along with part of the concrete repair), excavation stopped at this point.

Plate 16: Mortared stone layer 1032 along the north-east side of the Abbey Drain from the north-east West End Trench

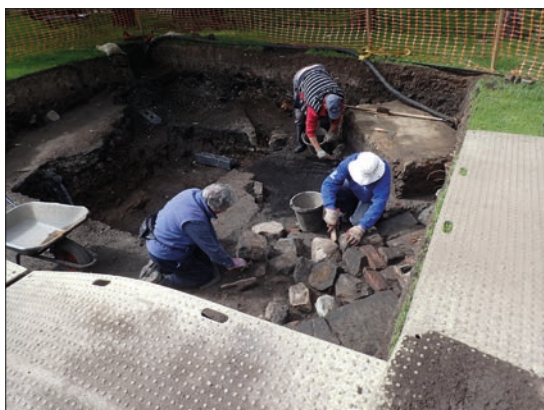
Plate 18: General view, cleaning 19th and 20 century structures, from NW

- 10.5.3** Excavation along the north west edge of the trench revealed that the layers 2002 and 2004 sealed the remains of a 19th or 20th century stone surface, which probably continued beyond the limits of the trench. The stone surface or pavement (2010) was formed by two large flat sandstones slabs along with smaller stones and bricks, covering an area 1.2 m long by 0.7 m wide and was 0.1m thick. Within the paving was a ceramic drainage gully chamber (2019) with a 0.24 m square open top and measured 0.18 m in height. It was probably for rain water or waste water. The drain was supported by a brick and rubble spread (2011) that was packed around the pipe and paving slabs.

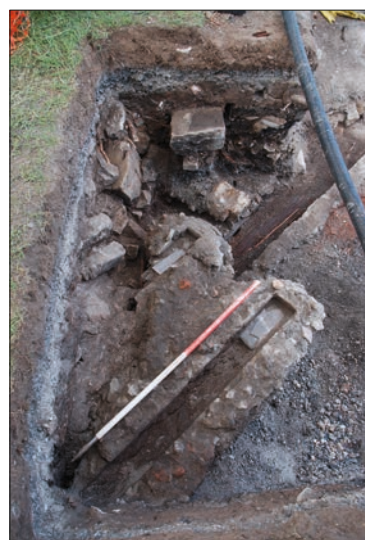
Plate 20: Concrete foundation 2026 from the south-east

- 10.5.5** The extension in the south-west of the trench revealed more of the concrete foundation (2026) and that the concrete had been broken and that an edge (2027), was exposed, (parallel north-west/south-east to the river). The edge could be traced for 2 m along the side of the

- 10.5.4** Excavation in the south-west corner below layer (2004) revealed a substantial rectangular concrete foundation (2012) that was 1.70 m long 0.95 m wide, and up to 0.5 m thick, with a brick and gravel foundation. The concrete had been poured in situ as the sides of the feature still bore the imprints of the wooden boards, used to contain the concrete. On the upper surface of the concrete was an L-shaped imprint from a possible structure. Two other concrete features, (2008 and 2026) were uncovered to the south and east of 2012, against the southern section of the trench. The first (2008) was 1.6 m long and 0.56 m wide and 0.31 m high with a channel running along the centre that was 1.10 m long, 0.25 m wide and 0.15 m deep. This channel was completely filled by decayed wood (2009), either from a beam or possibly a tree root. Slightly further to the east and higher up the section was another concrete foundation (2026). The trench was extended to the south at this point which revealed more of the concrete structure which was 1.48 m long and 0.8 m wide and 0.4 m thick, again with a channel in the middle that was 1.3 m long, 0.14 m wide and 0.1 m deep.

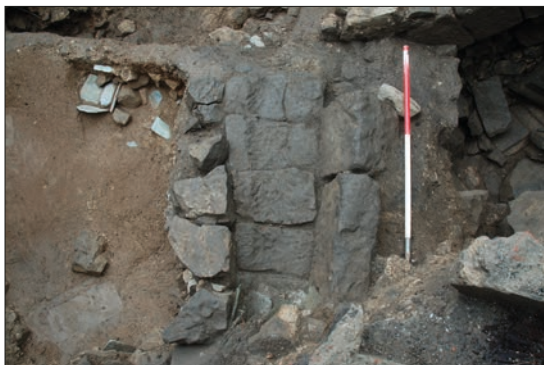
- 10.5.10** As excavation continued in the southern half of the trench, deposit 2005 was removed to reveal the top of a linear stone-built feature (2020). Layer 2006 sealed a deposit of light to mid-brown silty sand (2023) up to 0.4 m thick with occasional slate fragments and small subangular stones and gravel. Further excavation revealed that the linear feature (2020) was 1.34m long and between 0.83 m and 1.1 m wide, and was 0.28 m high and appeared to continue to the south-west section towards the river. This feature appears to be an open stone drain running south-west/north-east formed by a row of five large flat stones which formed the base with two rows of stones forming the side walls which narrowed toward the river. The south-east side wall consisted of three large stones up to 0.6 m long by 0.3 m wide and 0.2 m high. The north-west side wall was less regular and was built with smaller stones up to 0.3 m long by 0.2 m wide and 0.2 m high. The fill (2021) of the drain was similar to 2005 and consisted of light brown silty sand with frequent fragments of roofing slate and small and medium sub-angular stones.

Plate 21: Stone drain 2020 found along the exit of the Abbey Drain from the south-west

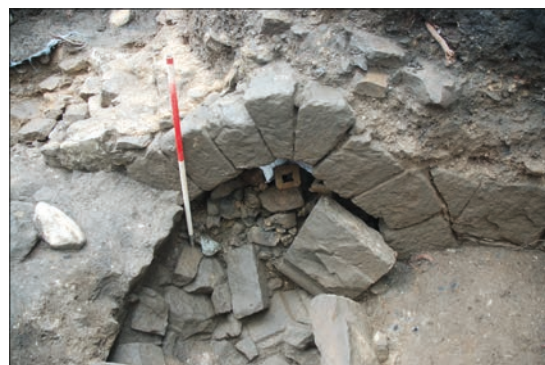
Plate 22: Archway (2018) for the Abbey Drain from the south

10.5.12 The full extent of the archway was not uncovered and only the upper arch was exposed. The arch was built with two triangular shaped keystones, measuring 0.3m by 0.2m wide, and eight rectangular stone blocks approximately 0.38 m by 0.28. The facing stones of the exterior wall (2033) were exposed on both sides of the arch and followed the line of the cut or edge (2015) that had been observed earlier in the excavation.

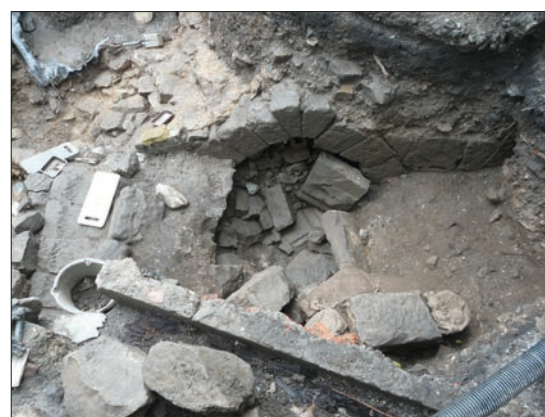
Plate 23: Details of Archway and channel

10.5.13 As layer 2022 was removed from the front of the archway (2018) which uncovered a possible channel leading towards the river, filled with loose brown silty sand and large architectural stone blocks along with fragments of roofing slate (2030). Given the potential importance and relatively undisturbed nature of this deposit, only a small section (1 m wide) was investigated by the archway and only loose material was removed to expose the larger stones to a depth of 0.3 m. Excavation within the channel revealed that the east side was composed of a firm mid-brown silty clay (2029) extending beyond the channel as the main deposit below layer 2022. On the west side there was a possible retaining wall and a single row of stones (2032) was exposed. These could be traced along the channel for 1.23 m. The stones were approximately 0.08 m wide, and the wall reached a height of 0.44 m. The wall was not fully exposed and excavation within the channel stopped at this point.

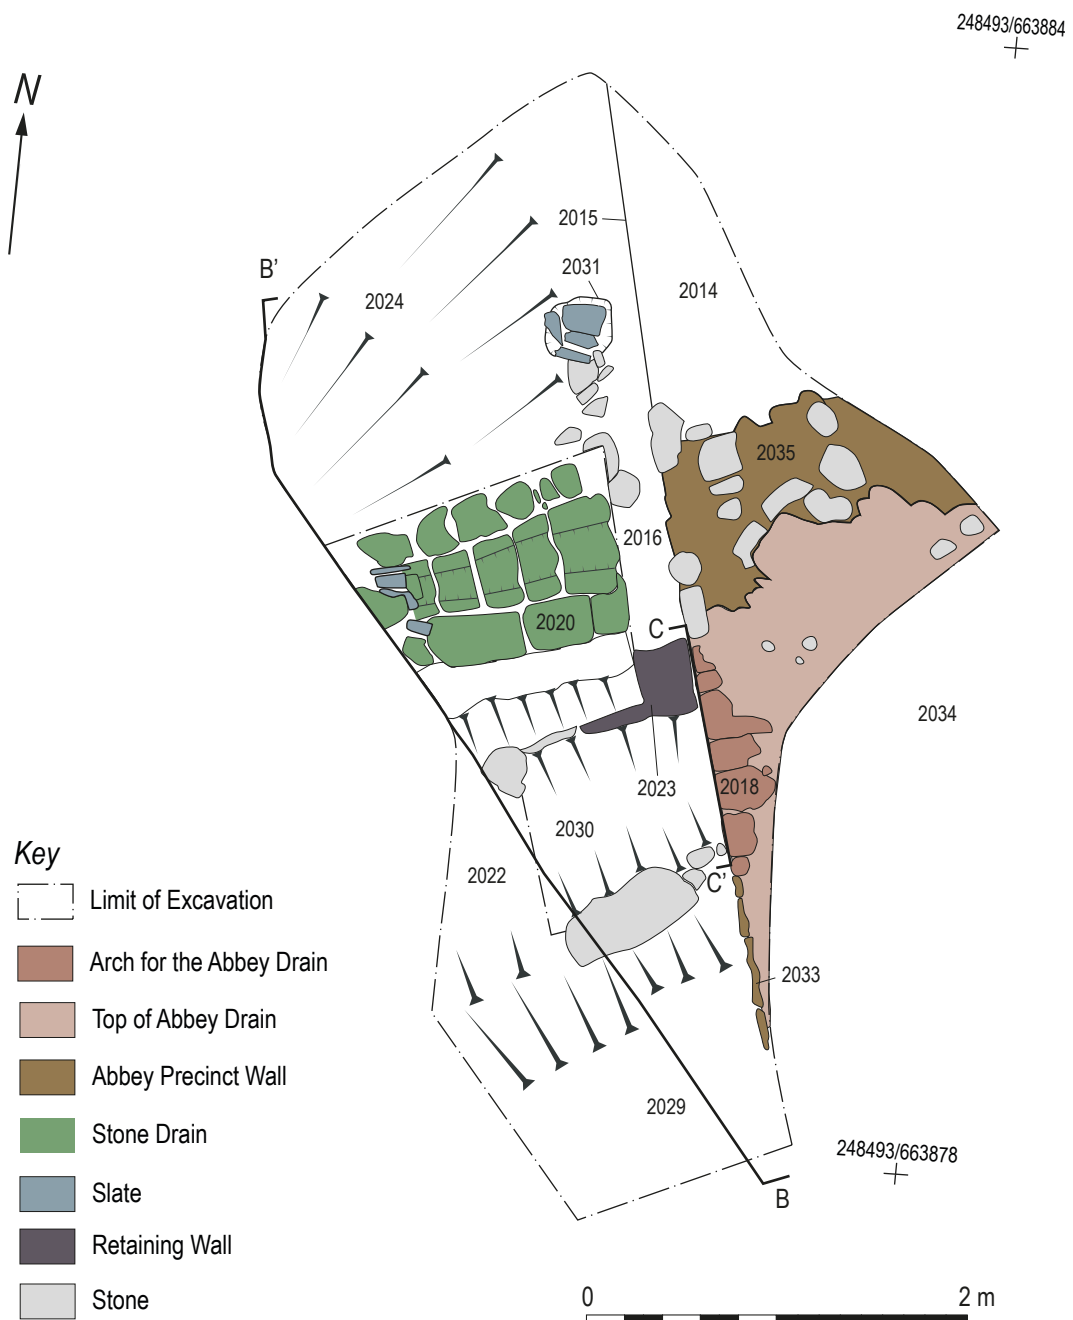
10.5.15 Excavation revealed that the facing stones of wall 2033 did survive and continued to the west of the archway. Three courses of stonework were exposed with a maximum height of 0.39 m, the facing stones were up to 0.4 m long and 0.32 m wide and 0.23 high. The joints between the stones were very tight with no evidence of mortar bonding. The stones of the possible retaining wall (2032) in the channel at the front of the archway were not fully exposed or removed, but the large stone next to the arch was seen to lie against the arch and exterior wall, and was not built into the fabric of the main wall. This stone lies at an angle and leans in to the channel and it may have moved from its original position and these stones may be supporting the small drain 2020 rather than the channel exiting from the archway.

Figure 10: Plan of the exit 1818 of the Abbey Drain with the River Cart, the stone drain 2020, the remnants of the precinct wall 2033/2035/2036 and the slate feature 2031 in WET

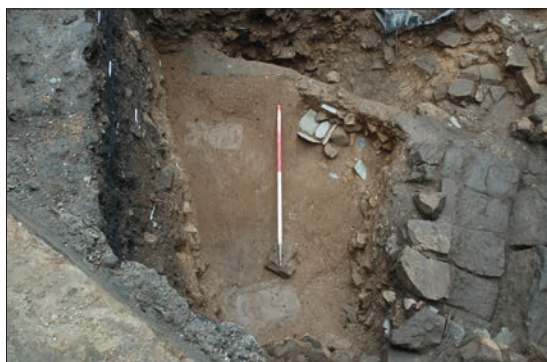
Plate 24: Detail of the original clay river bank

10.5.16 To the west of drain 2020, excavation revealed a similar sequence of deposits where layers 2005 and 2006 sealed deposits 2023 which in turn overlay deposit 2016 which was uncovered in the small trial trench. In this area, 2016 was quite extensive and may have been used as deliberate levelling layer, as the underlying light brown clay layer (2024) sloped downwards towards the river.

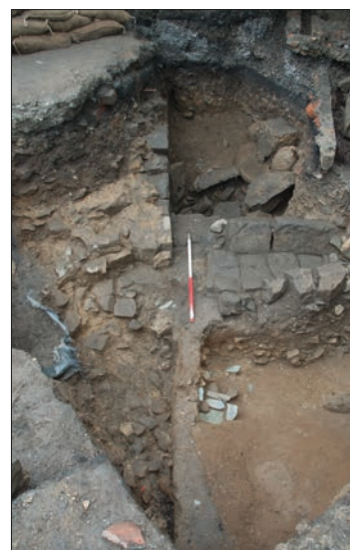
Plate 25: General view of the trench showing the edge between the Abbey precinct wall and the original river bank

10.5.17 The cut or edge 2015 that was revealed when layers 2023 and 2024 were removed, marked the edge of the wall (2033) leading off from the archway and appears to have been built in a foundation trench, that was cut into the natural sloping clay (2024). Within the foundation trench (2015) was the masonry core of the Abbey Drain (2034) and wall (2035), which sloped downwards to the west from the highest point next to the concrete base for the manhole. Excavation in this area removed a deposit of loose yellow/brown mortar and stone fragments (2014) from this area, that was up to 0.9 m thick at the deepest point by the western trench edge. It appears that the original masonry may have been robbed and the stones re-used after the Abbey went out of use, leaving only mortar and building debris (2014).

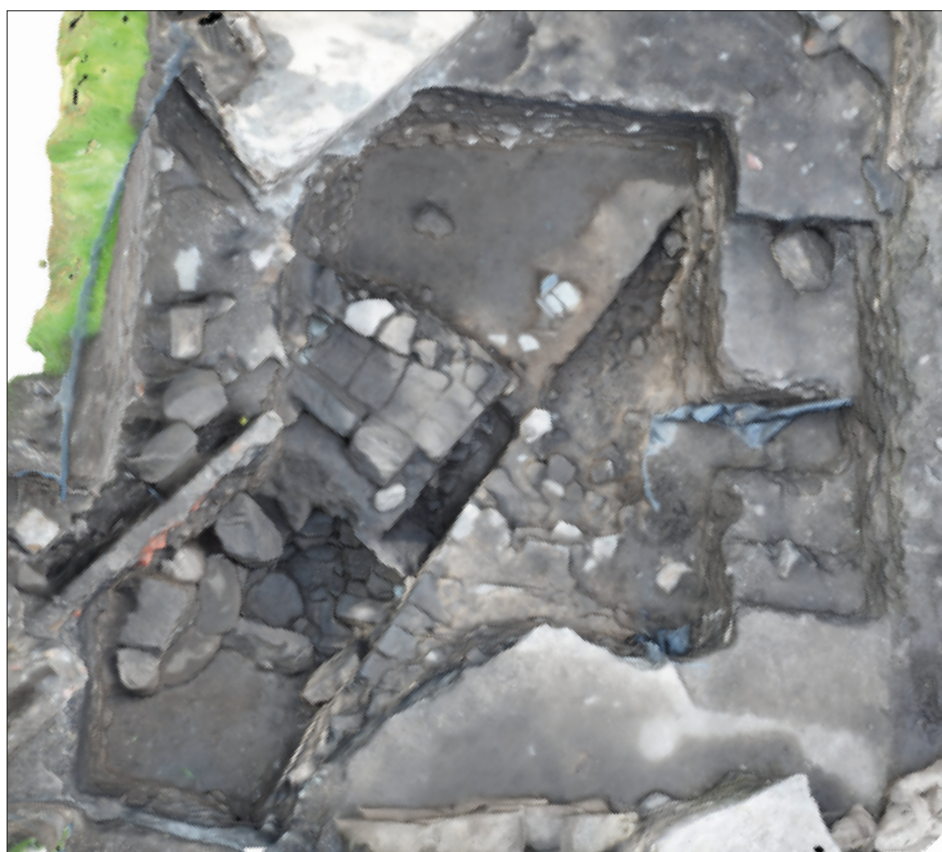
Plate 26: 3 D modelling of the Excavation Trenches

10.7.2 At the end of the excavation, 3D models were made of each of the excavation trenches. These models were produced by one of the volunteers (Katherine Scott). She had previously volunteered with the ongoing Historic Environment Scotland 'Scotland's Rock Art Project' which uses laser scans and photogrammetry to record prehistoric rock art. Katherine used the skills and techniques she had acquired on that project to produce 3D images of each trench. These models allow the viewer to move around the trench and to zoom in to specific areas or feature, providing a visual record of the excavation.

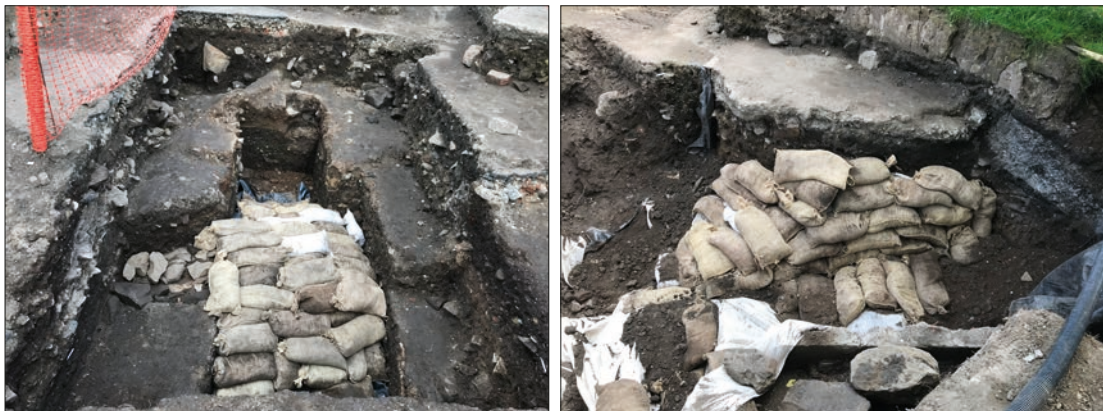
Plate 28: Photos of sandbags

10.8.1 Before the Big Dig started, a structural engineer from Renfrewshire Council assessed and commented on the methodology, with the aim of ensuring that the project would not have an adverse effect on the structural integrity of the Abbey Drain. This information was shared with Historic Environment Scotland, as part of the Scheduled Monument Consent process. At the start of the excavation white sand bags were placed in the Drain to fill gaps in the existing internal blocking at the western end. The roof of the Drain at the west end is protected by the concrete base above that provides a foundation for the access manhole so was not affected by the excavation. Material from within the Drain was not removed in case this affected the stability of the structure. At the end of the Big Dig, sand bags and geotextile were used to cover and protect exposed stonework prior to backfilling.

- 10.3.20** On completion of the excavation, the stone roof slabs of the Abbey Drain were covered with geotextile and protected with sandbags prior to backfilling. The trench was backfilled and the turf re-laid. Once complete the interior of the Abbey Drain was checked below the location of the trench for any movement or damage - none was observed.

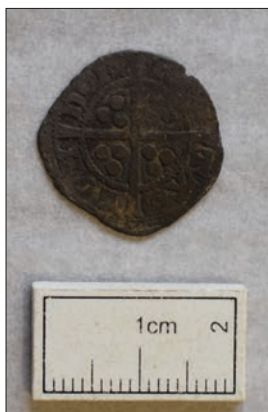
Plate 31: Edward 1 penny

11.6.1 Four coins were recovered including an Edward I silver penny that would date to the period 1272-1307. This was just after the priory was established (it didn't become an Abbey until 1219) and covers part of the Scottish Wars of Independence when the monastery was burnt (1307) by Edward I. Another interesting coin was the George III copper penny (1797), sometimes known as a cartwheel penny due to their size and decoration. The other two coins were a Queen Victoria bronze penny (1876) and a modern Queen Elizabeth I, 1992 ten pence piece.
